Device **TC29x**
Marking/Step **ES-BC, BC**
Package **see Data Sheet**

10320AERRA

This Errata Sheet describes the deviations from the current user documentation.

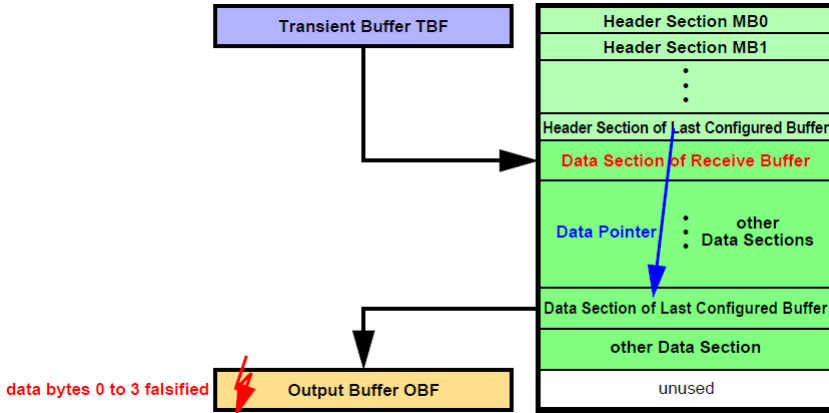
Figure 1 Message buffer transfer from Message RAM to OBF

a) Message buffer transfer from Message RAM to OBF

When the message buffer has its payload configured to maximum length (PLC = 127), the OBF word on address 00h (payload data bytes 0 to 3) is overwritten with unexpected data at the end of the transfer.

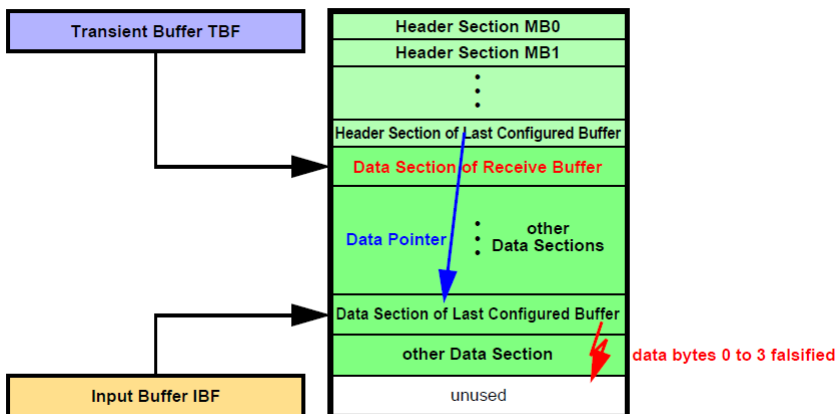
Figure 2 Message buffer transfer from IBF to Message RAM

b) Message buffer transfer from IBF to Message RAM

After the Data Section of the selected message buffer in the Message RAM has been written, one additional write access overwrites the following word in the Message RAM which might be the first word of the next Data Section.

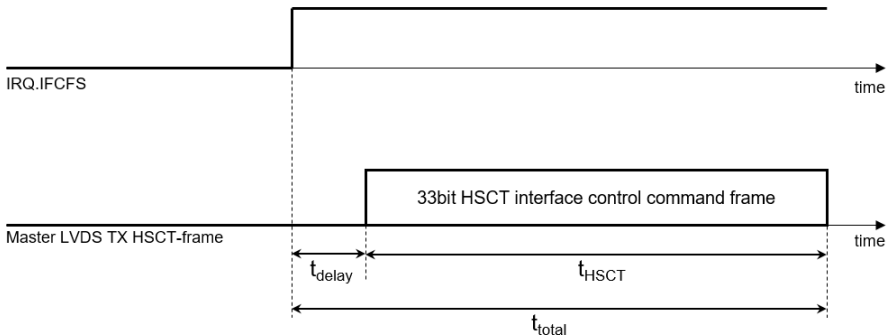
The value THVAL is not available in the memory at the specified point in time.

the user might falsely assume that also the actual sending on the LVDS TX port has already occurred once the IRQ.IFCFS flag is set, which is not true.

Instead the timing shown in **Figure 6** applies.

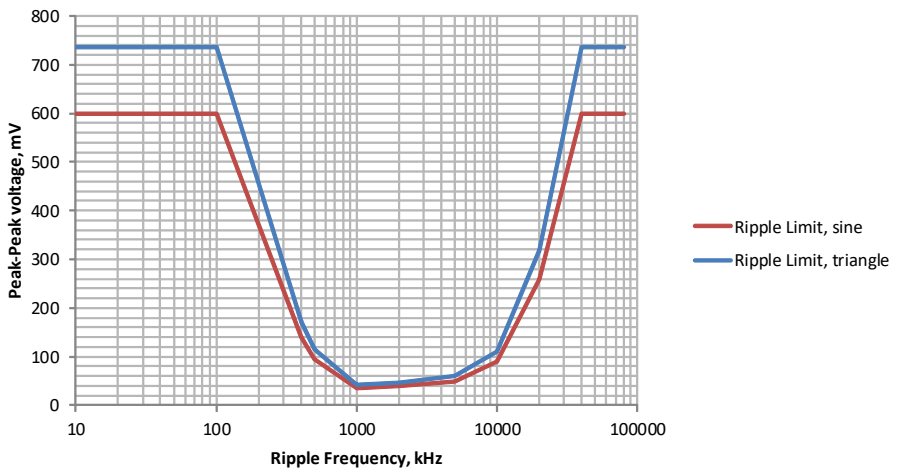
Figure 12 Ripple Voltage vs. Frequency Characteristic

The internal back-up clock is sensitive to specific power supply voltage disturbance/ripple caused by a voltage ripple intrinsic to DC-DC converters. Specific conditions such as insufficient filtering of the ripple may lead to improper behavior of the start-up scheme of the back-up clock, and thus stuck-at state during the start-up of the microcontroller until this condition is removed.

The acceptable voltage vs. frequency characteristic is portrayed below on the chart:

The diagram reflects acceptable ripple level during the cold start of the microcontroller at the respective VDDP3/VEXT/VEVRSB supply of the PMS subsystem, depending on the device and package type, as shown in the following table.

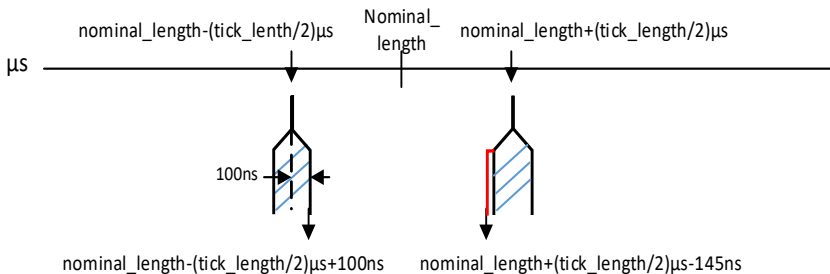
Figure 14 SENT Tolerance of this Design Step

In this design step the range is delimited as follows:

- The lower border is $\text{nominal_value} - (\text{tick_length}/2) \mu\text{s} + 100 \text{ ns}$
- The upper border is $\text{nominal_value} + (\text{tick_length}/2) \mu\text{s} - 145 \text{ ns}$.

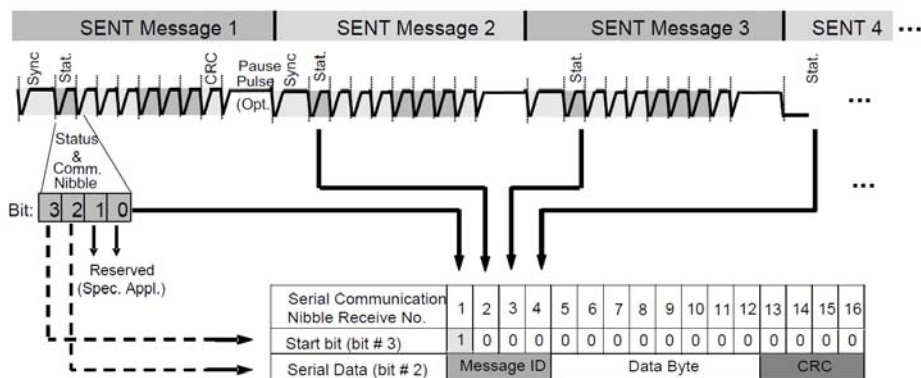
Figure 15 Short Serial Message, Serial Data Encoding over 16 messages

Figure 15 shows a corrected version of this figure.
