# TMS320F2810, TMS320F2811, TMS320F2812 DSPs

## 1 Introduction

This document describes the silicon updates to the functional specifications for the TMS320F2810, TMS320F2811, and TMS320F2812 digital signal processors (DSPs).

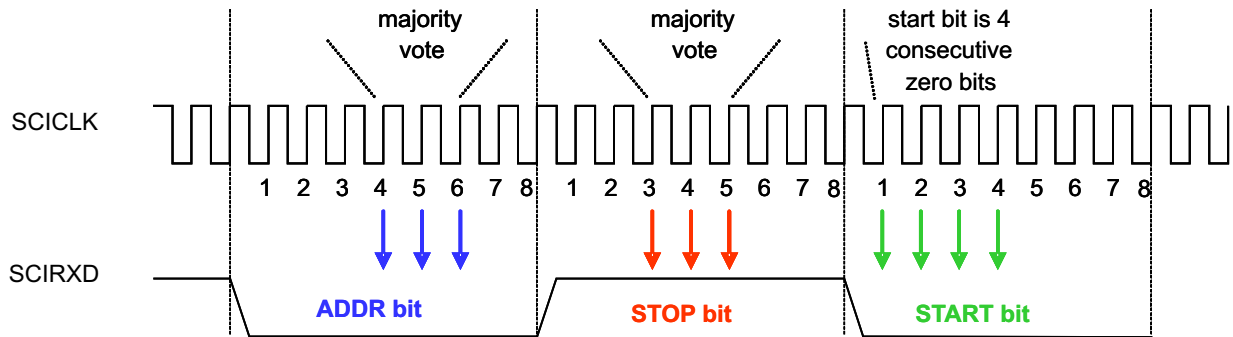
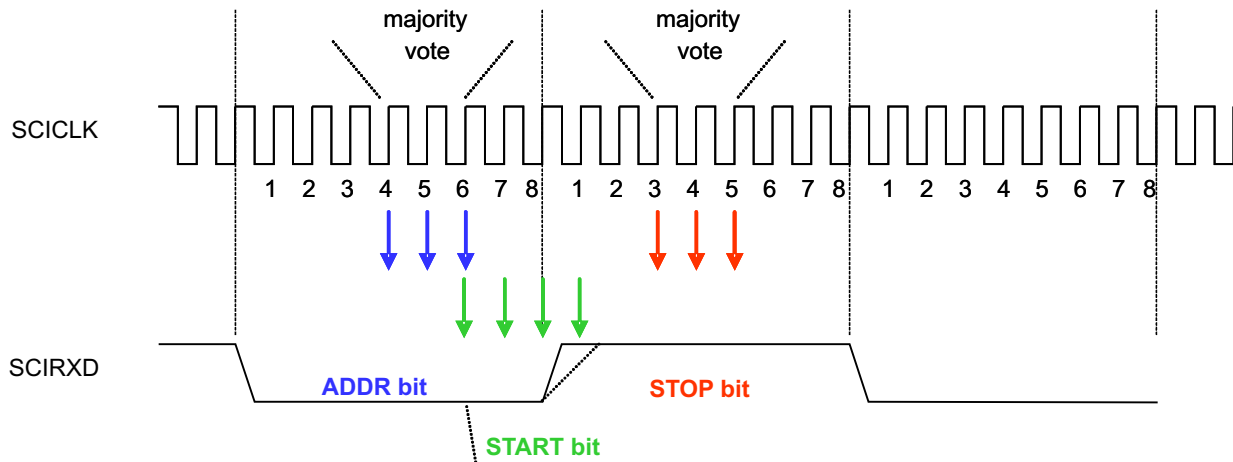
**Figure 5-1. Difference Between Expected and Erroneous Operation of START Bit**

**Details** The SCI does not look for the STOP bit after the ADDR bit. Instead, the SCI starts looking for the start bit beginning on sub-sample 6 of the ADDR bit. Slow rise time from the ADDR bit to the STOP bit can cause a false START bit to occur since the 4th sub-sample for the start bit may be sensed low.

**Workaround(s)** Program the baud rate of the SCI to be slightly slower than the actual. This will cause the 4th sub-sample of the false START bit to be delayed in time, and therefore occur more towards the middle of the STOP bit (away from the signal transition region). The amount of baud-slowng needed depends on the rise time of the signal in the system. Alternatively, the IDLE mode of the SCI module may be used, if applicable.
