## CHANGE NOTIFICATION

PCN#020617

### **Subject: Notification of Change to LTC4015 Die and Datasheet**

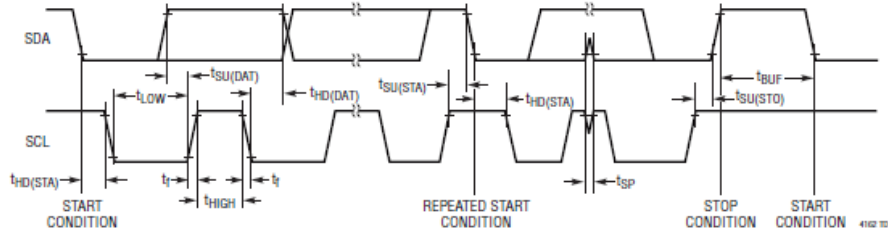
## I<sup>2</sup>C TIMING DIAGRAM

New I2C timing diagram,  
Added PEC functionality(use is optional).

For Improved clarity  
Added: Legend, Read/Write protocol w&w/o PEC,  
SMBus Alert Response Protocol w&w/o PEC  
Corrected Repeated Start condition S=> Sr
