P1010 Chip Errata

This document details all known silicon errata for the P1010. The following table provides a revision history for this document.

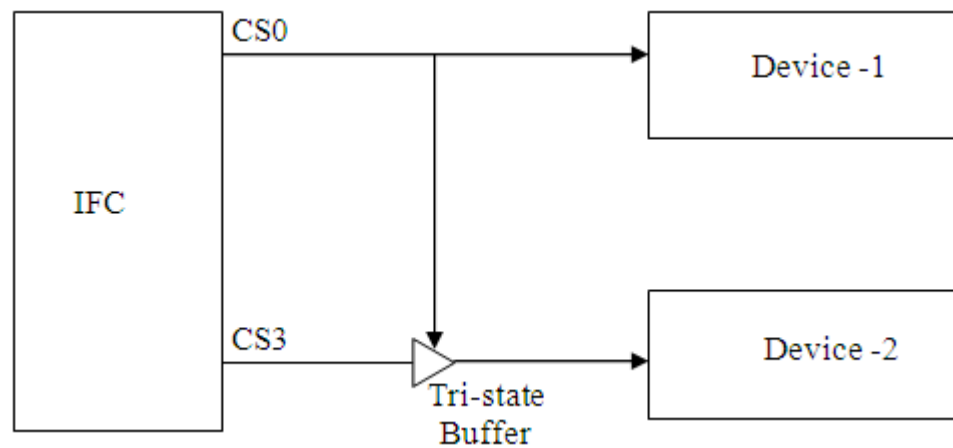
The following figure shows one of the possible ways to gate IFC_CS3.

Workaround: If IFC_CS3 is used, gate IFC_CS3 while booting from NAND or NOR. Software should select IFC_CS3 using `PMUXCR[24:25] = 0b11`.
