Device **TC29x**
Marking/Step **ES-BC, BC**
Package **see Data Sheet**

10320AERRA

This Errata Sheet describes the deviations from the current user documentation.

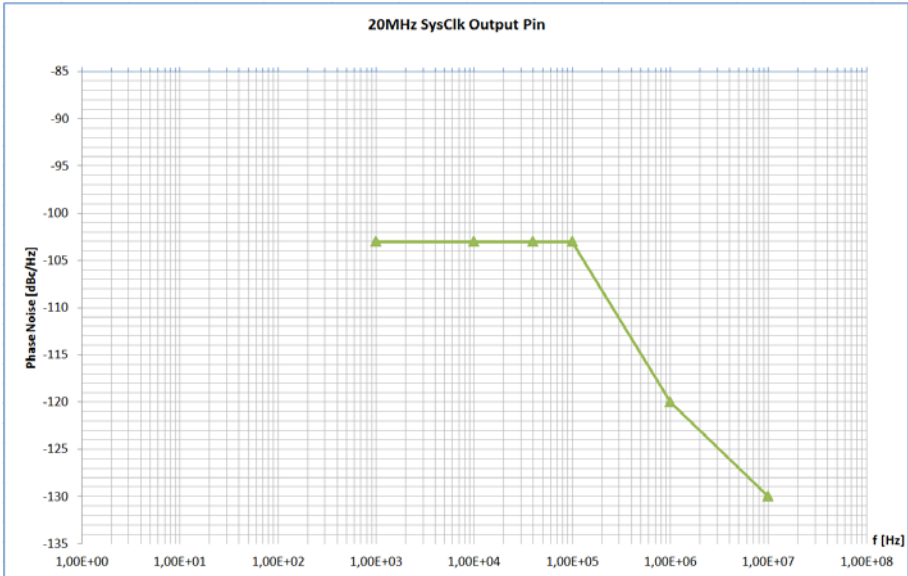
Figure 5 Phase Noise Density on SysClk Output Pin

The diagram below shows the phase noise density on the SysClk pin when no application pattern but only the HSSL/HSCT subsystem is running:

When designing the PLL for an HSSL/HSCT ASIC, the values for I_{PN} and J_{ABS20} above and ultimately $BER_{20} = 10^{-12}$ can be achieved with the following recommendations:

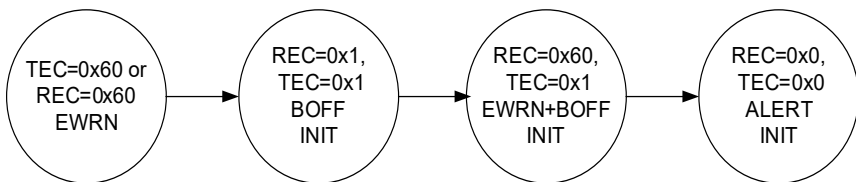
Figure 8 Alert Interrupt Behavior in case of Bus-Off

The MultiCAN module shows the following behavior in case of a bus-off status:

When the threshold for error warning (EWRN) is reached (default value of Error Warning Level EWRN = 0x60), then the EWRN interrupt is issued. The bus-off (BOFF) status is reached if TEC > 255 according to CAN specification, changing the MultiCAN module with REC and TEC to the same value 0x1, setting the INIT bit to 1_B, and issuing the BOFF interrupt. The bus-off recovery phase starts automatically. Every time an idle time is seen, REC is incremented. If REC = 0x60, a combined status EWRN+BOFF is reached. The corresponding interrupt can also be seen as a pre-warning interrupt, that the bus-off recovery phase will be finished soon. When the bus-off recovery phase has finished (128 times idle time have been seen on the bus), EWRN and BOFF are cleared, the ALERT interrupt bit is set and the INIT bit is still set.

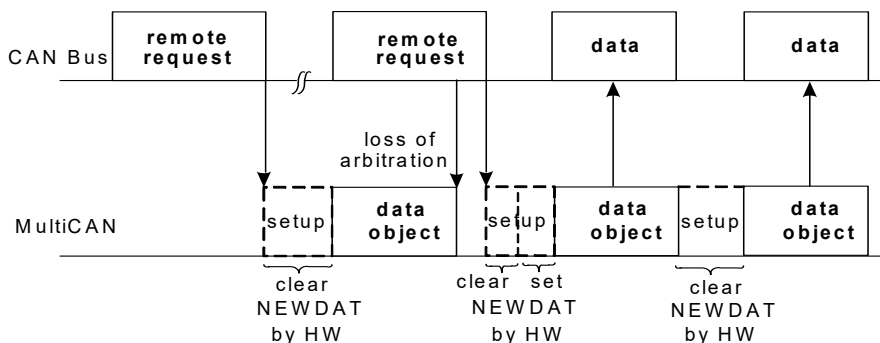
Figure 9 Loss of Arbitration

When the appropriate message object (data frame) triggered by the first remote frame wins the arbitration, it will be sent out and $NEWDAT$ is not reset. This leads to an additional data frame, that will be sent by this message object (clearing $NEWDAT$).

There will, however, not be more data frames than there are corresponding remote requests.
